38 743

## Installation:

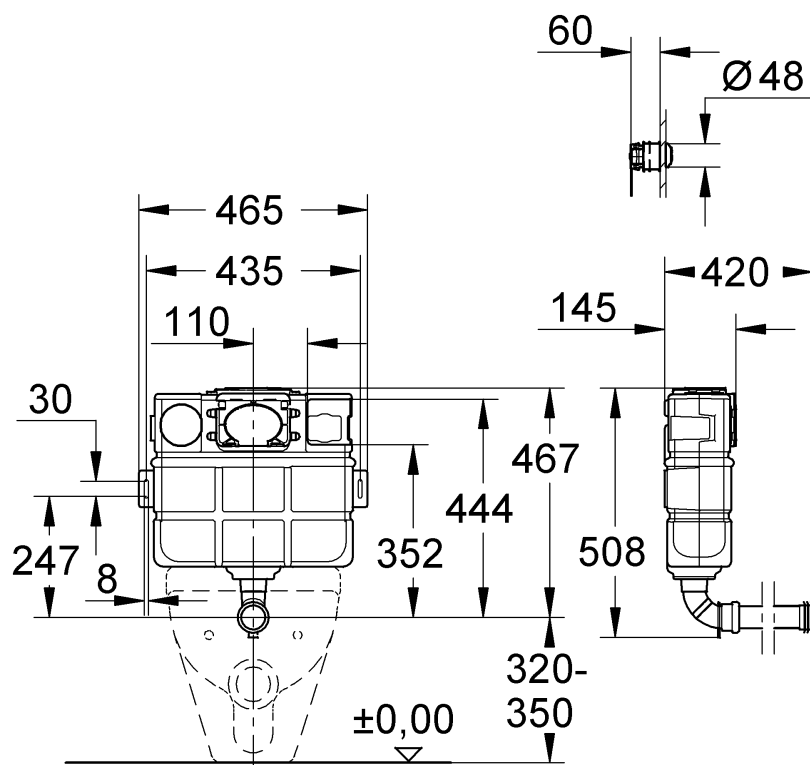
#### Parts delivered:

Cistern with protection plates

Flush valve
Rosette and buttons

Filler valve with stand pipe
Pneumatic actuation

Flushpipe and connector

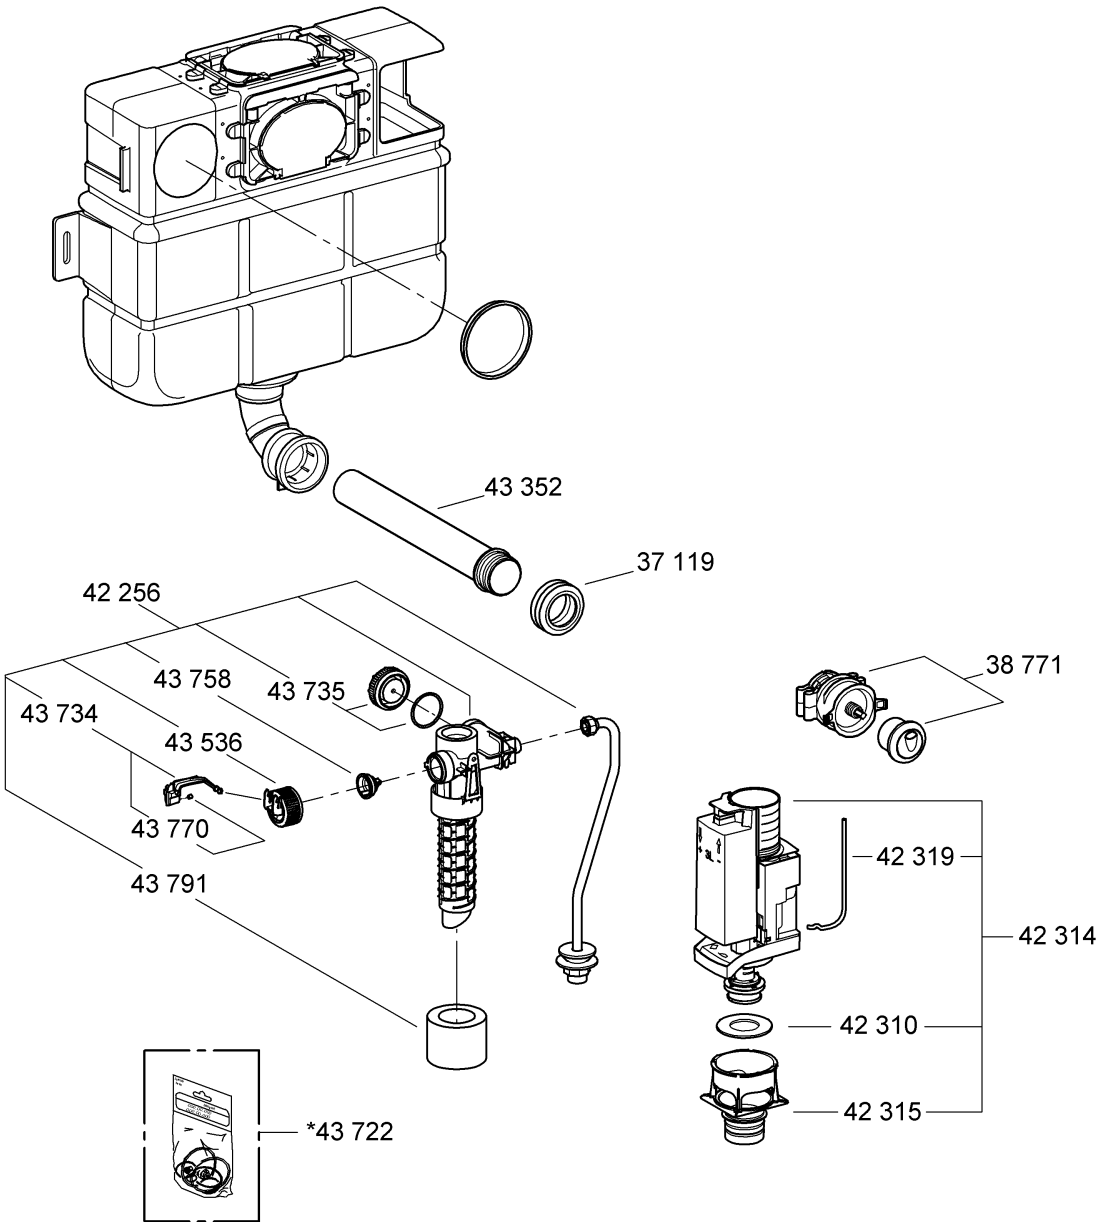
Spare parts:

Part No	Description	Part No	Description
42 314 000	Discharge valve, dual flush	42 256 000	Filler valve with stand pipe
42 315 000	Valve seat	43 352 000	Flush pipe
38 771 000	Actuation, complete	37 119 000	Rubber pan connector

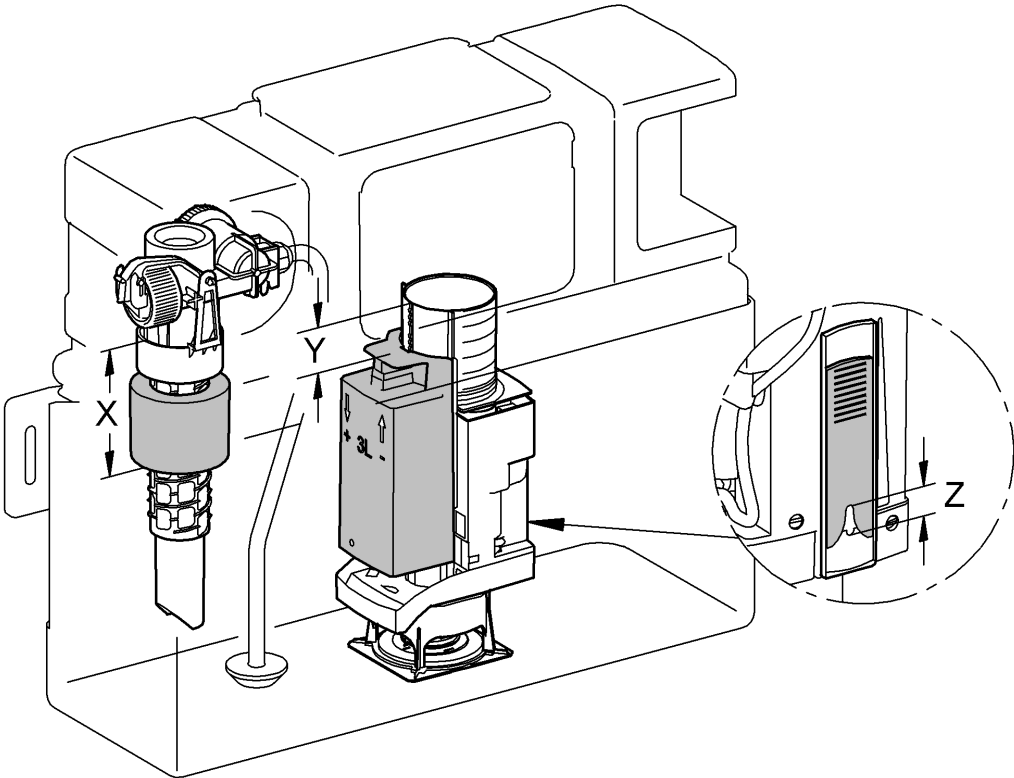
Adjustment instructions:

X	Y	Z
full flush: 6 ltr. reduced flush: 3,5 ltr. (factory setting)	88 mm	29 mm	9,5 mm
full flush: 4,5 ltr. reduced flush: 3 ltr.	98 mm	26 mm	> 18 mm
full flush: > 6 ltr. reduced flush: 4 ltr.	88 mm	41 mm	closed

- the polystyrene float on the filler valve regulates the water level for the cistern, the filler valve is factory set to 6 litres and can set to 4,5 litres.

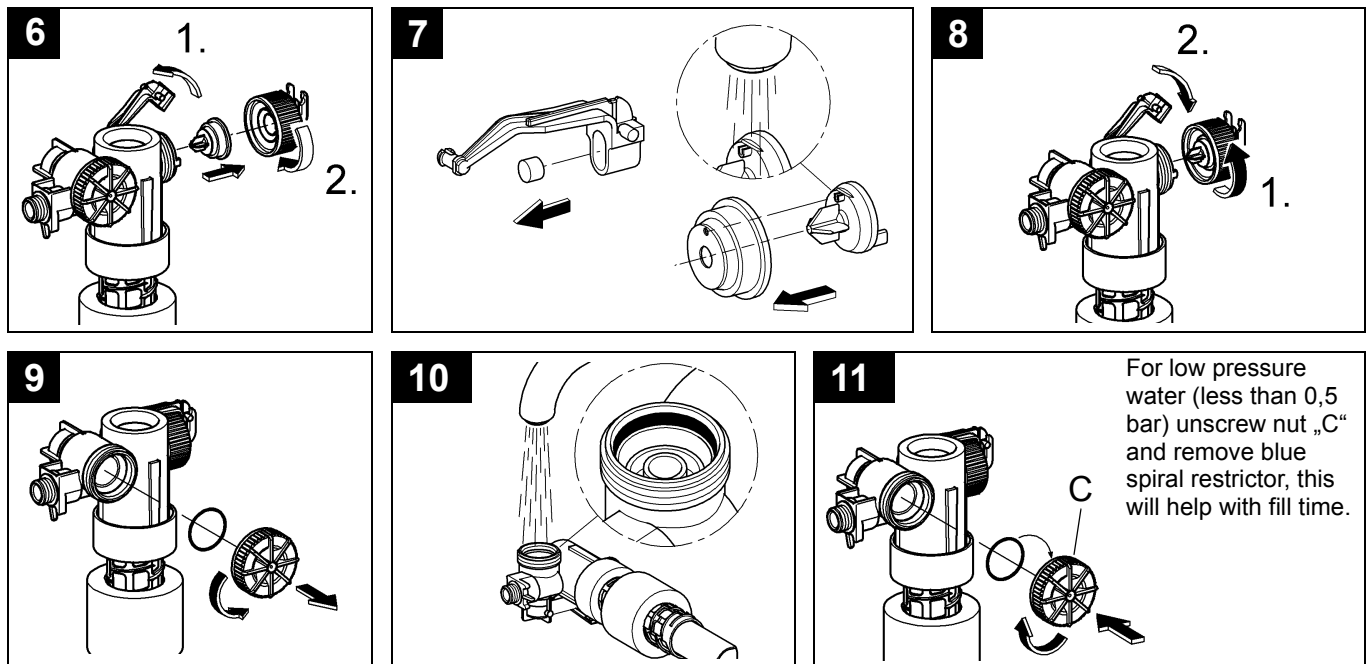
## Maintenance: Filler valve

Fault	Cause	Remedy
<b>Water continually flowing into pan, through the internal overflow</b>	<ul style="list-style-type: none"> <li>• Filler valve not shutting off</li> <li>• Water level has risen above the internal overflow pipe</li> </ul>	<ul style="list-style-type: none"> <li>- Check membrane washer within fill valve for any obstruction caused by debris or damage</li> <li>- adjust polystyrene float on filler valve so that the correct water level is achieved inside the cistern</li> </ul>
<b>Water continually flowing into pan, through the seal in cistern outlet point</b>	<ul style="list-style-type: none"> <li>• Drop valve not seating</li> </ul>	<ul style="list-style-type: none"> <li>- check seating washers and seating for any debris or damage around seal, clean if necessary</li> <li>- check seating of discharge valve</li> </ul>
<b>Cistern does not flush, there is no water</b>	<ul style="list-style-type: none"> <li>• No water supply to the cistern</li> <li>• Air hose connection is impaired</li> </ul>	<ul style="list-style-type: none"> <li>- check water supply</li> <li>- check isolating valve &amp; any isolating points</li> <li>- check air hose is connected correctly</li> <li>- ensure that the air tube is not kinked</li> </ul>
